**SAS Superstructure**

**Daily Diary Report by Bid Item**

Contract No.: 04-0120F4

Diary #: 003 Const Calendar Day: 308 Date: 13-Jul-2010 Tuesday

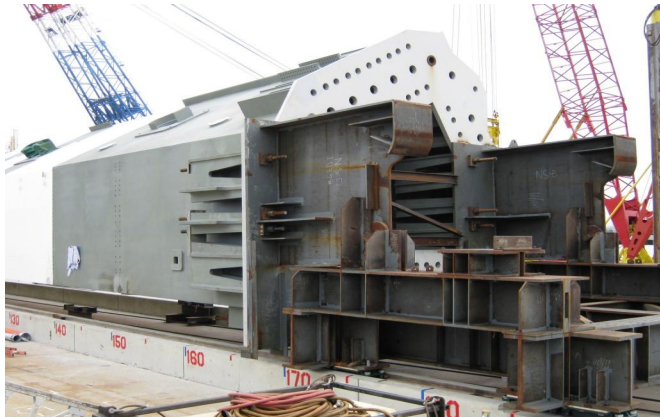
South shaft on barge attached to tip-up cart

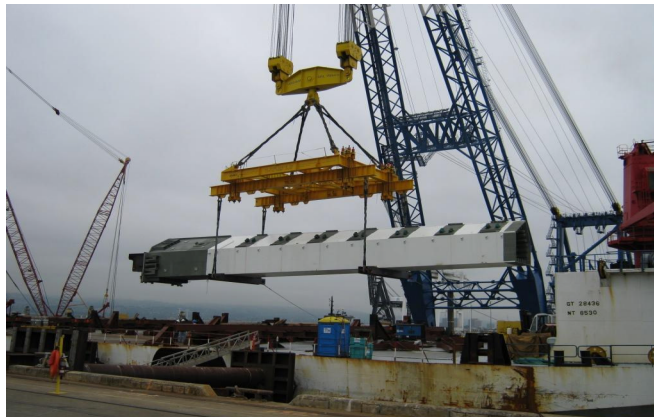
Off-loading of West shaft

The West shaft was off-loaded at 09:00.

A full account of labor and equipment was not able to be collected due to limited access inside the customs enforcement area. The Left Coast Lifter shear leg crane was being used for 3 hours to off-load the West shaft. The off-loading of smaller parts was being done by the pier 7 whirley crane.

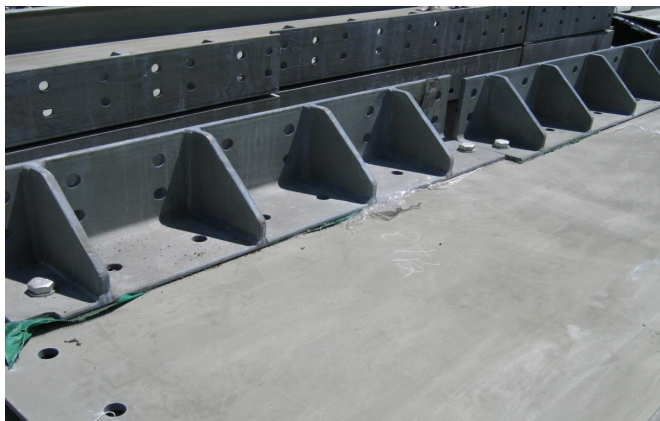
I accompanied Jake Van Enckevort to look at the strut facades. There was some uncertainty regarding how the façade angles were attached to the façades. In ABF's cost estimate, they assumed all bolts were installed at ZPMC, which would cause a lot of extra work for removal of the bolts prior to installing the PTFE. Each façade angle is attached with only 2 bolts (see attached photo).

Façade angles attached with only 2 bolts per angle

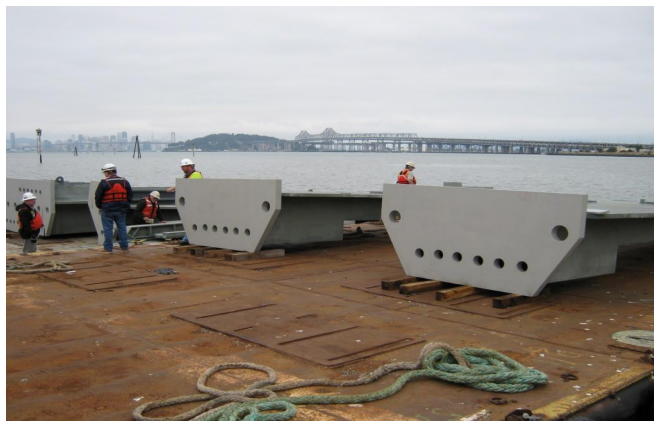
From 09:00 until 10:00, Caltrans/ABF joint arrival inspection was done for all 10 shear plates (a1N, a1S, a2N, a2S, b1E, b1W, b2E, b2W, cE, & cW). No shipping damage was noticed. Along with myself, the following people were also involved in the inspection:

Shear plate arrival inspection
